**POTENTIALLY RESPONSIBLE PARTIES (PRP) OVERSIGHT REPORT
FOR
SAN JACINTO RIVER WASTE PITS SITE
HOUSTON, HARRIS COUNTY, TEXAS**

U.S. Environmental Protection Agency Region 6
1445 Ross Avenue
Dallas, Texas 75202

June 7, 2010

Dynamac Corporation
1202 Executive West
Richardson, Texas 75081
(214) 575-3344

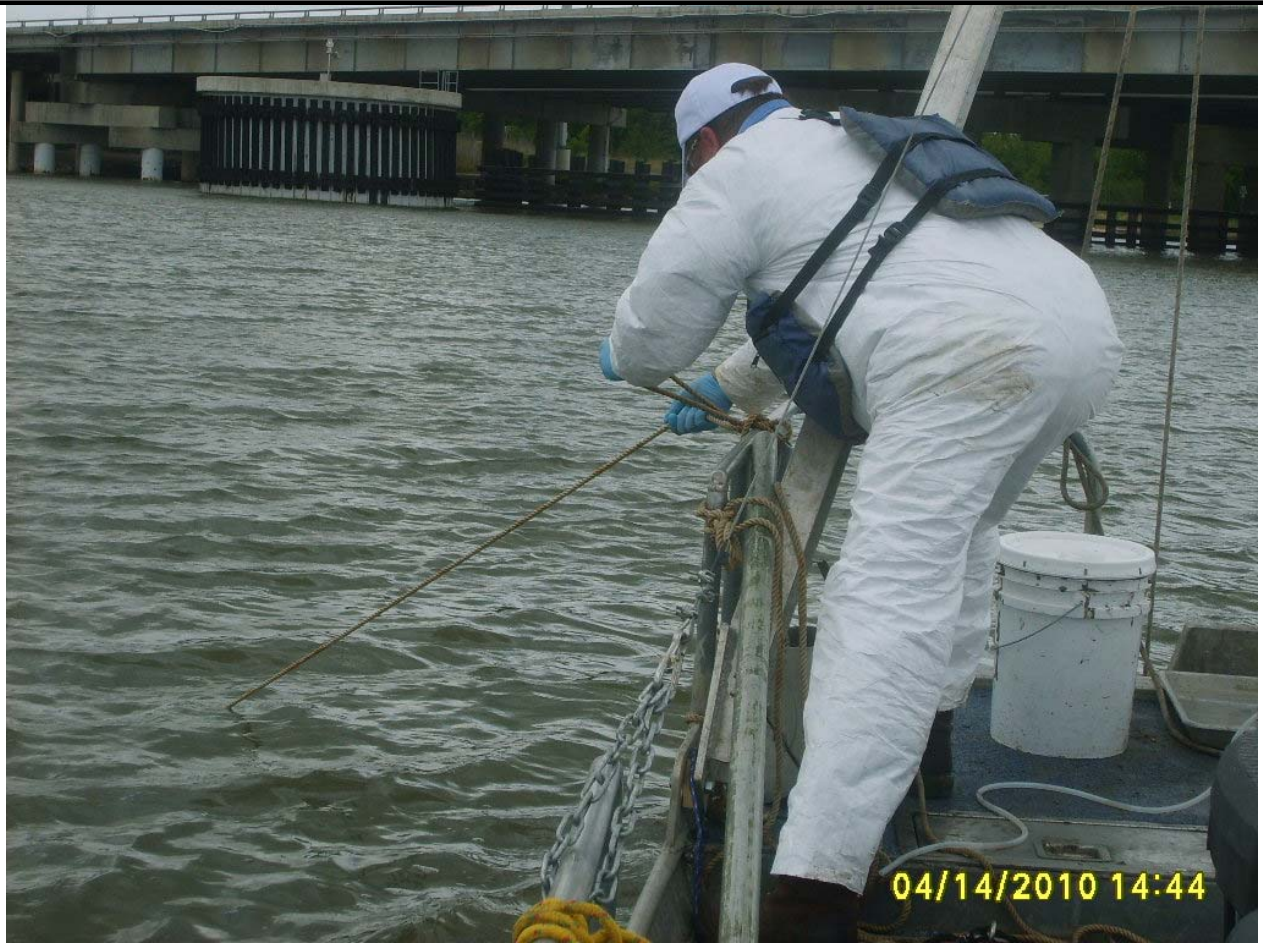
Logbook Photo #	102-0784
US EPA ID / Task Order Number	TXN000606611 / TO-0002-10-03-02
Site	San Jacinto River Waste Pits
Location Address	29.7944 N, 95.0625 W
City, State, ZIP code	Baytown, Texas
County	Harris
Direction/Orientation	Northeast
Date	April 14, 2010
Time	1207 hrs
Photographer	Karen Berecz (START)
Witness	Jason Kase (PRP Contractor – Anchor QEA)
Description:	
Reeling in Ponar Sampler from SJD2.

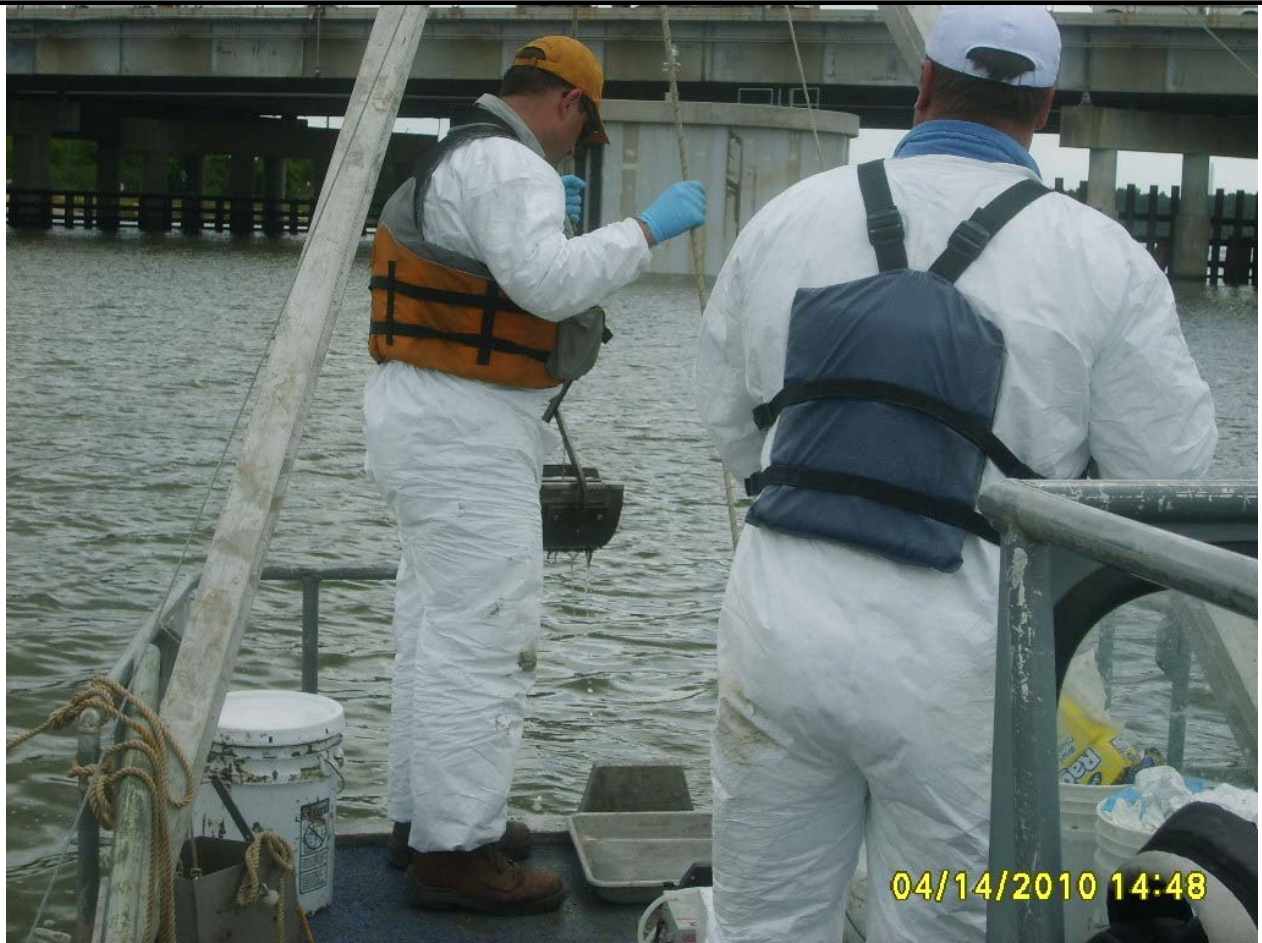
Logbook Photo #	102-0785
US EPA ID / Task Order Number	TXN000606611 / TO-0002-10-03-02
Site	San Jacinto River Waste Pits
Location Address	29.7944 N, 95.0625 W
City, State, ZIP code	Baytown, Texas
County	Harris
Direction/Orientation	Southeast
Date	April 14, 2010
Time	1444 hrs
Photographer	Karen Berecz (START)
Witness	Jason Kase (PRP Contractor – Anchor QEA)
Description:	
Anchoring the boat in location at SJE4.

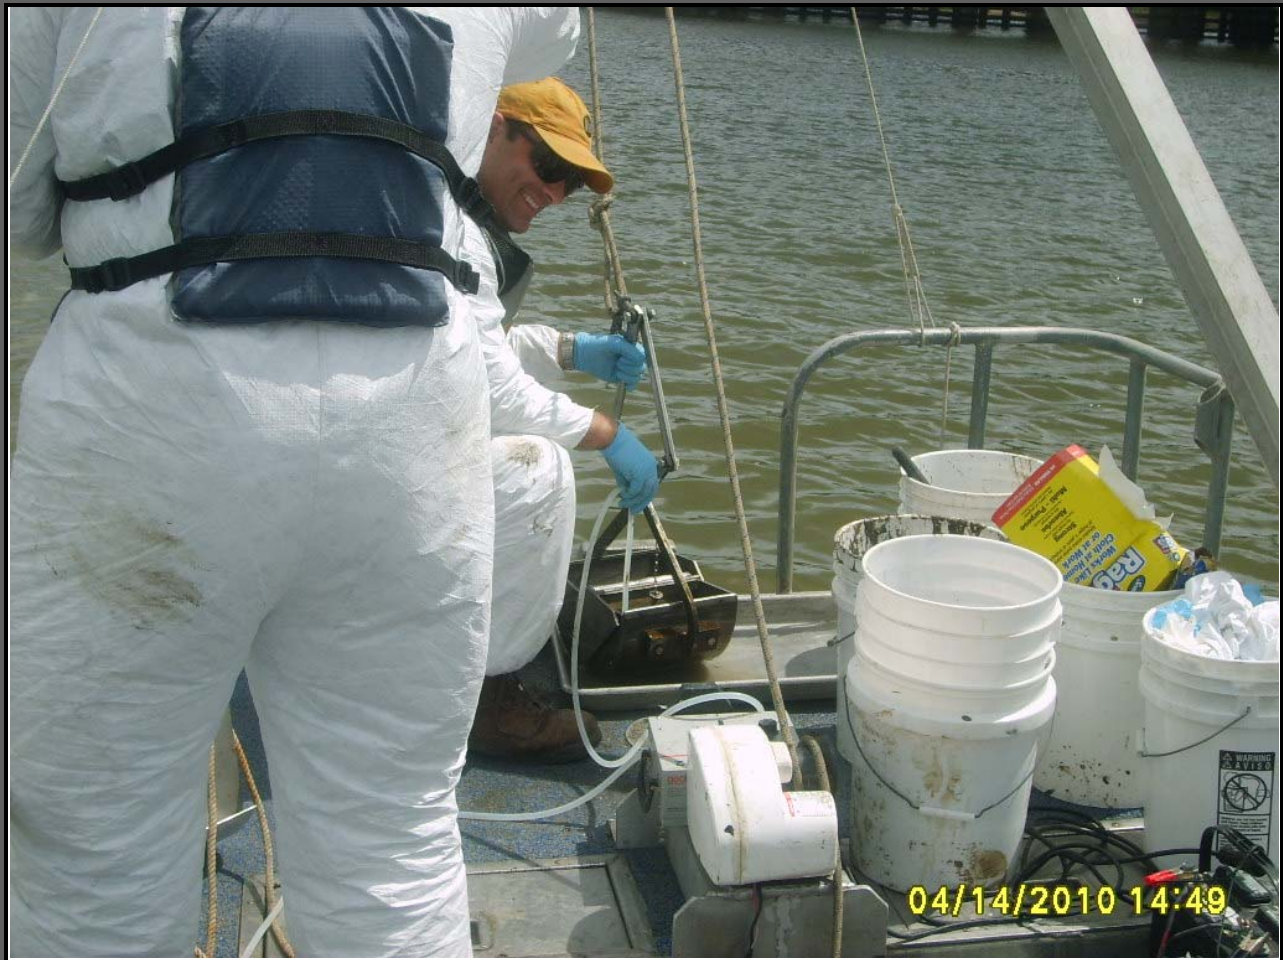
Logbook Photo #	102-0786
US EPA ID / Task Order Number	TXN000606611 / TO-0002-10-03-02
Site	San Jacinto River Waste Pits
Location Address	29.7944 N, 95.0625 W
City, State, ZIP code	Baytown, Texas
County	Harris
Direction/Orientation	West
Date	April 14, 2010
Time	1448 hrs
Photographer	Karen Berecz (START)
Witness	Jason Kase (PRP Contractor – Anchor QEA)
Description:	
Raising Ponar from sample location SJE4.

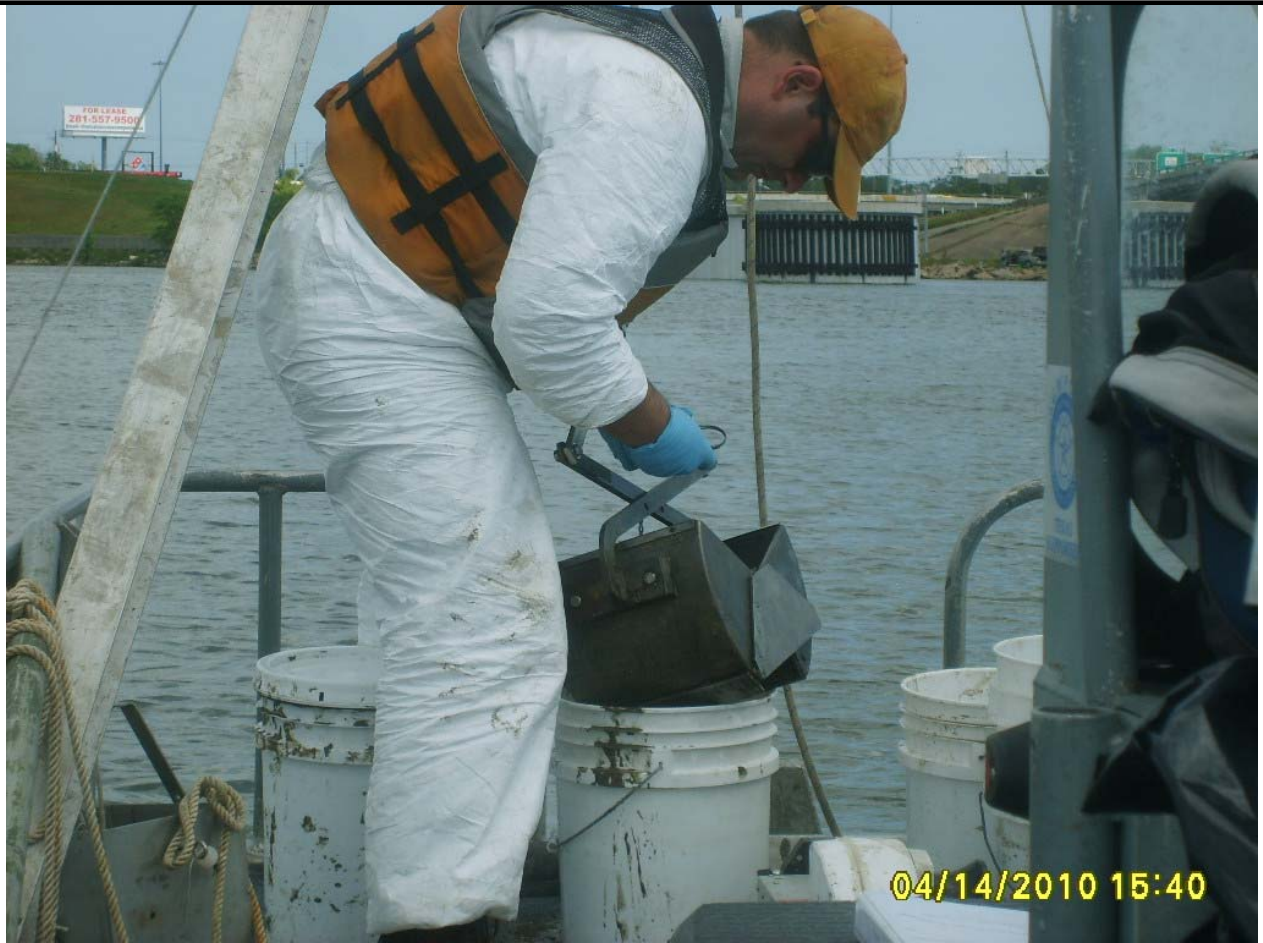
Field equipment and supplies included; sampling equipment, stainless steel utensils, decontamination supplies, sample containers, coolers, shipping containers, log books and forms, personal protection equipment and personal gear. Protective gear was required to minimize the possibility of cross-contamination between sampling locations. During oversight activities it was observed that protective gear was changed between sampling locations to prevent cross-contamination, but on one occasion (Tuesday, April 13, 2010) it was noted that Sarah Ballard of Anchor QEA, forgot to don Tyvek coveralls during sample collection and handling at location SJA4. Also, photo documentation (Photo 102-0790

and 102-0791) shows Sarah Ballard handling a pre-cleaned, decontaminated, stainless-steel bowl and spoon without gloves worn, prior to collection of sample location SJE4. Other than the above noted and photo-documented incidents there were no other occasions of protective gear discretions.

Logbook Photo #	102-0791
US EPA ID / Task Order Number	TXN000606611 / TO-0002-10-03-02
Site	San Jacinto River Waste Pits
Location Address	29.7944 N, 95.0625 W
City, State, ZIP code	Baytown, Texas
County	Harris
Direction/Orientation	Northwest
Date	April 14, 2010
Time	1450 hrs
Photographer	Karen Berecz (START)
Witness	Jason Kase (PRP Contractor – Anchor QEA)
Description:	
Unwrapping clean spoon for sampling of SJE4.

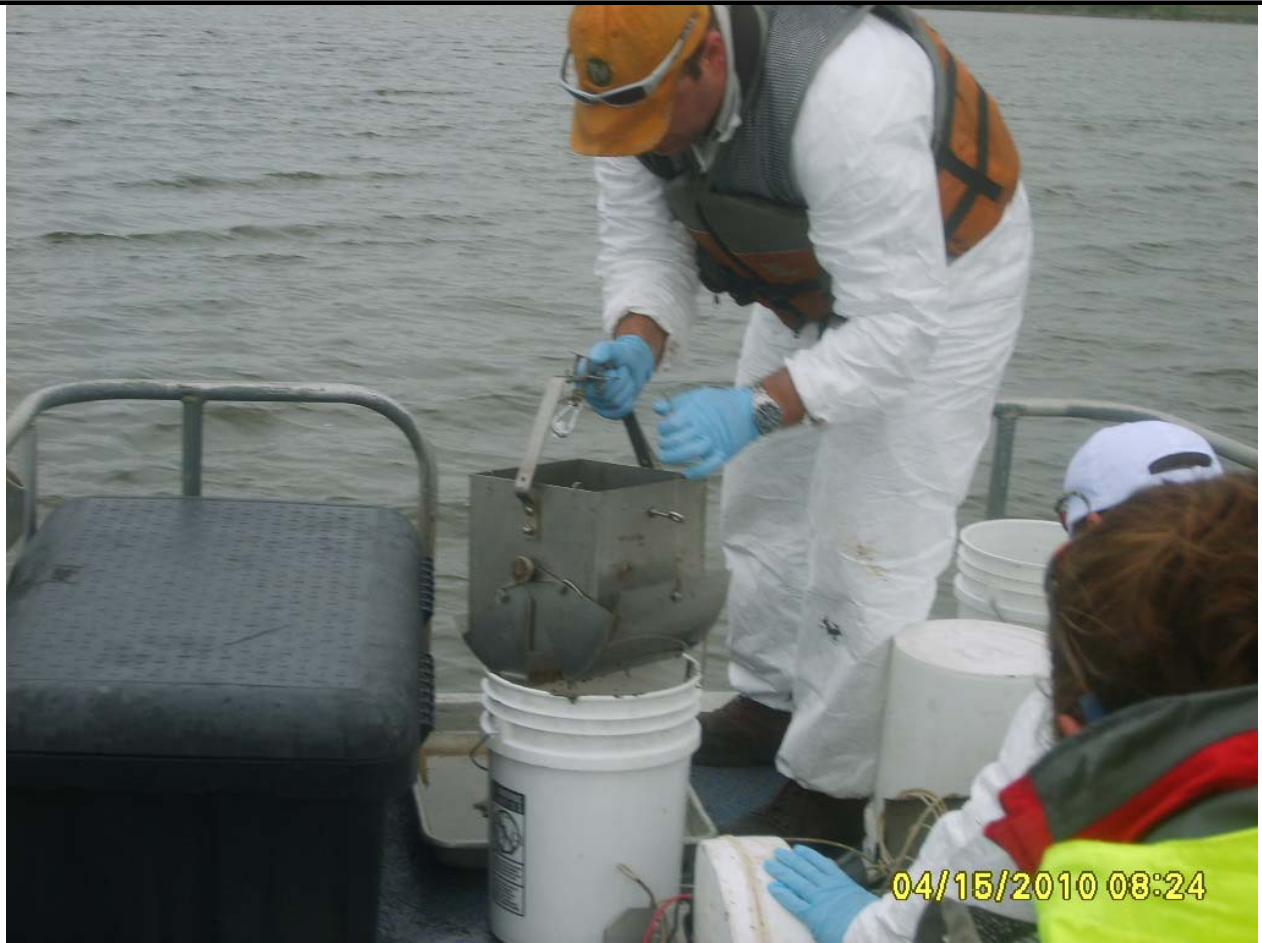
Logbook Photo #	102-0796
US EPA ID / Task Order Number	TXN000606611 / TO-0002-10-03-02
Site	San Jacinto River Waste Pits
Location Address	29.7944 N, 95.0625 W
City, State, ZIP code	Baytown, Texas
County	Harris
Direction/Orientation	Northeast
Date	April 15, 2010
Time	0823 hrs
Photographer	Karen Berecz (START)
Witness	Jason Kase (PRP Contractor – Anchor QEA)
Description:	
Sample from Ponar being discarded due to poor sample recovery at SJB1.

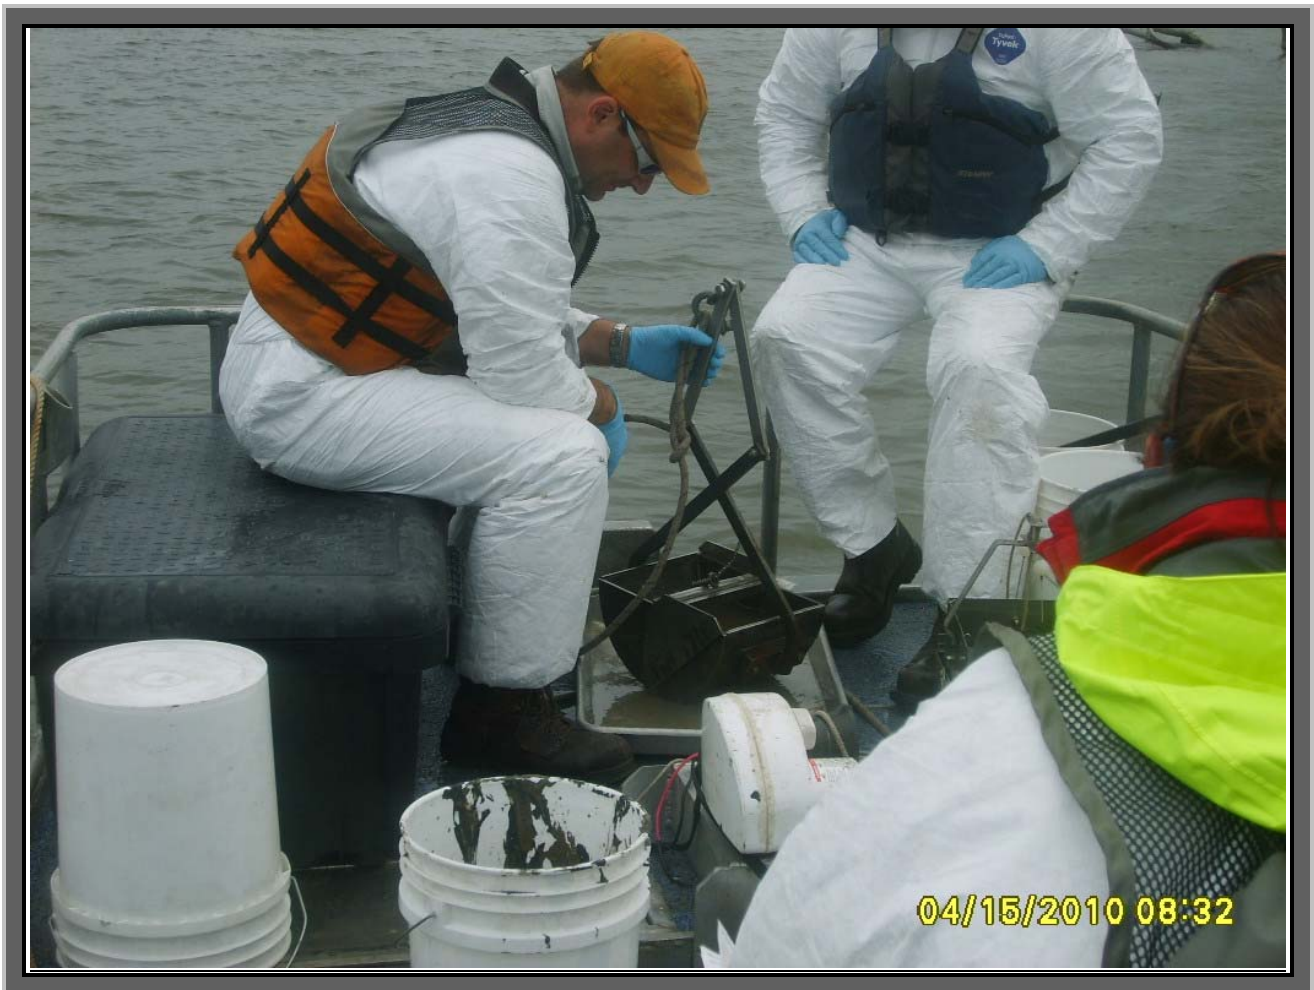
Logbook Photo #	102-0797
US EPA ID / Task Order Number	TXN000606611 / TO-0002-10-03-02
Site	San Jacinto River Waste Pits
Location Address	29.7944 N, 95.0625 W
City, State, ZIP code	Baytown, Texas
County	Harris
Direction/Orientation	Northeast
Date	April 15, 2010
Time	0824 hrs
Photographer	Karen Berecz (START)
Witness	Jason Kase (PRP Contractor – Anchor QEA)
Description: Putting discarded sample into IDW buckets at SJB1.

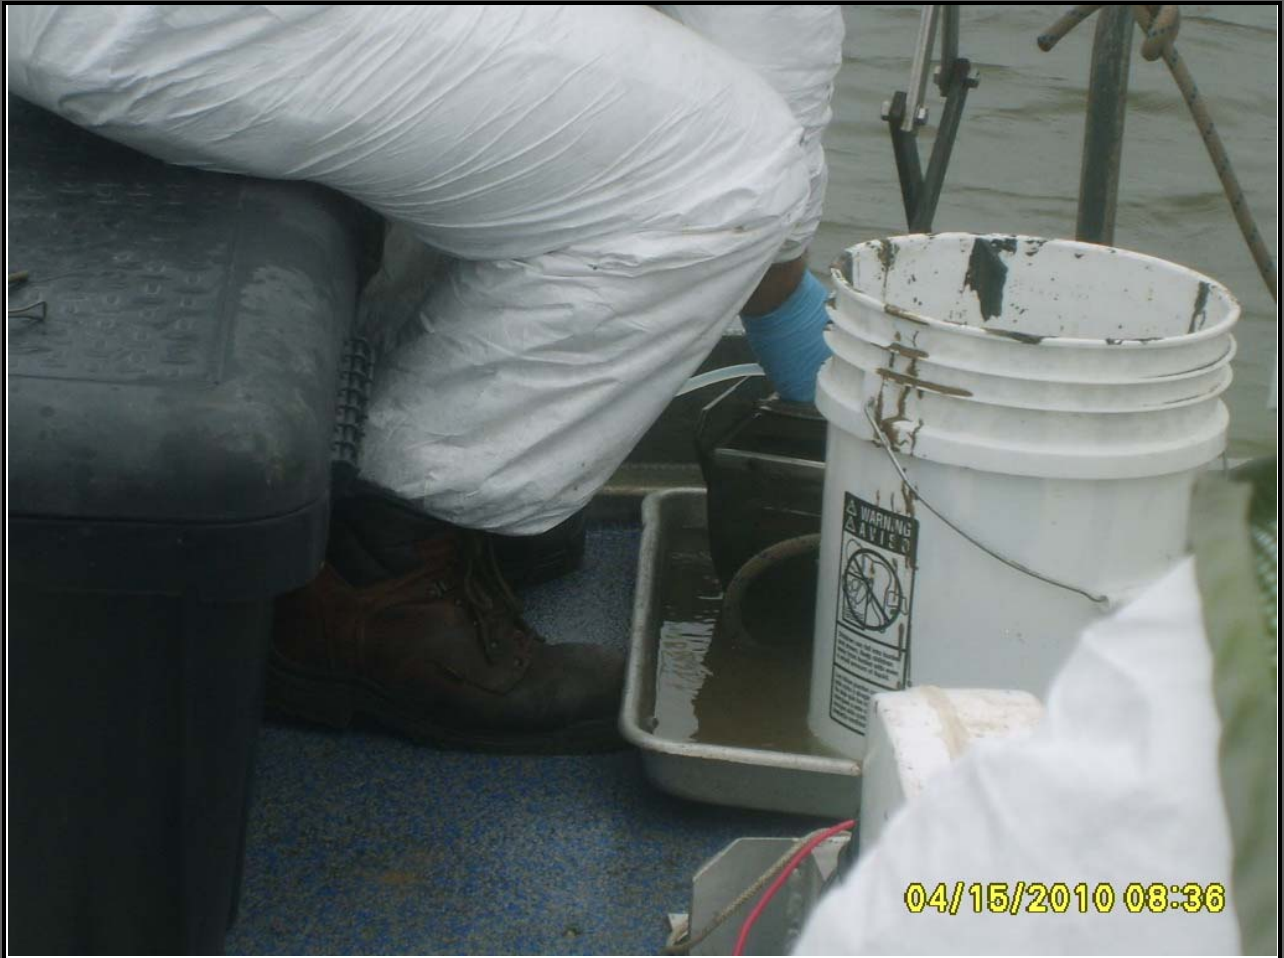
Logbook Photo #	102-0798
US EPA ID / Task Order Number	TXN000606611 / TO-0002-10-03-02
Site	San Jacinto River Waste Pits
Location Address	29.7944 N, 95.0625 W
City, State, ZIP code	Baytown, Texas
County	Harris
Direction/Orientation	Northeast
Date	April 15, 2010
Time	0832 hrs
Photographer	Karen Berecz (START)
Witness	Jason Kase (PRP Contractor – Anchor QEA)
Description:	
With Ponar Sampler after re-attempting sampling at SJB1.

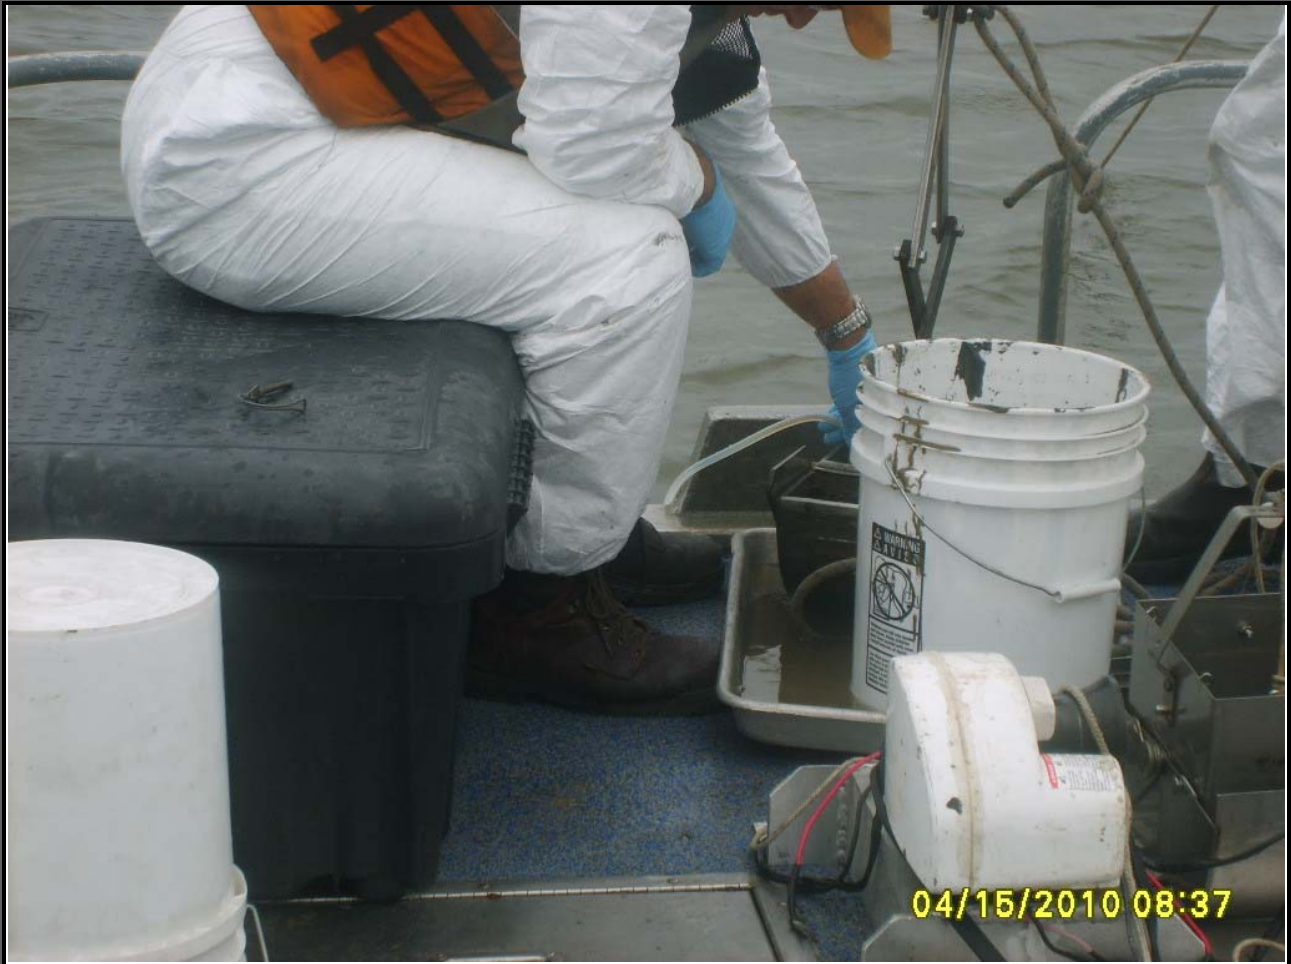
Logbook Photo #	102-0799
US EPA ID / Task Order Number	TXN000606611 / TO-0002-10-03-02
Site	San Jacinto River Waste Pits
Location Address	29.7944 N, 95.0625 W
City, State, ZIP code	Baytown, Texas
County	Harris
Direction/Orientation	Northeast
Date	April 15, 2010
Time	0836 hrs
Photographer	Karen Berecz (START)
Witness	Jason Kase (PRP Contractor – Anchor QEA)
Description:	Siphoning water off of Ponar Sample at SJB1.

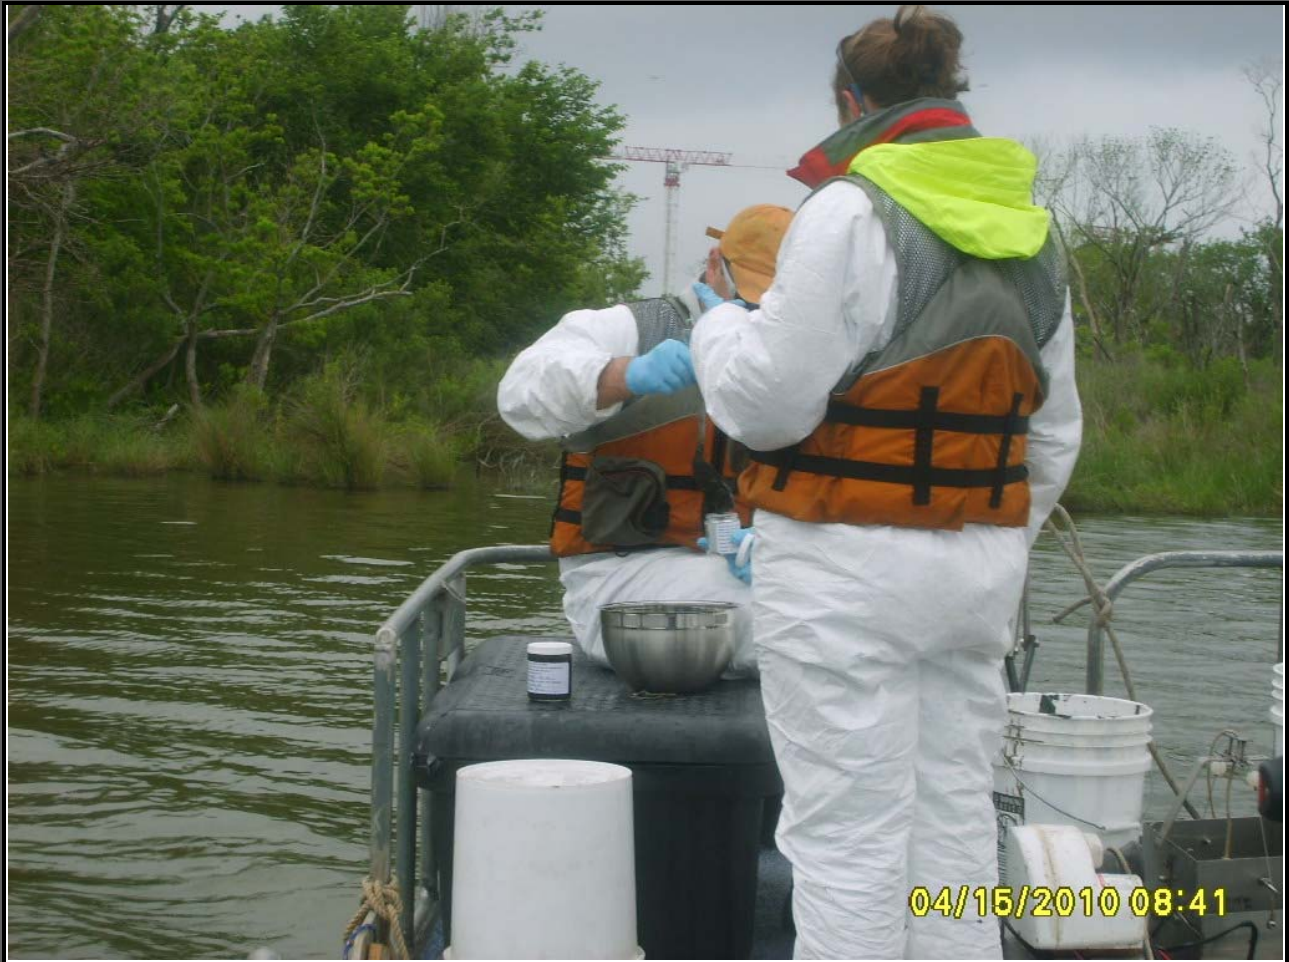
Logbook Photo #	102-0800
US EPA ID / Task Order Number	TXN000606611 / TO-0002-10-03-02
Site	San Jacinto River Waste Pits
Location Address	29.7944 N, 95.0625 W
City, State, ZIP code	Baytown, Texas
County	Harris
Direction/Orientation	Northeast
Date	April 15, 2010
Time	0837 hrs
Photographer	Karen Berecz (START)
Witness	Jason Kase (PRP Contractor – Anchor QEA)
Description:	
Siphoning water off of Ponar Sample at SJB1.

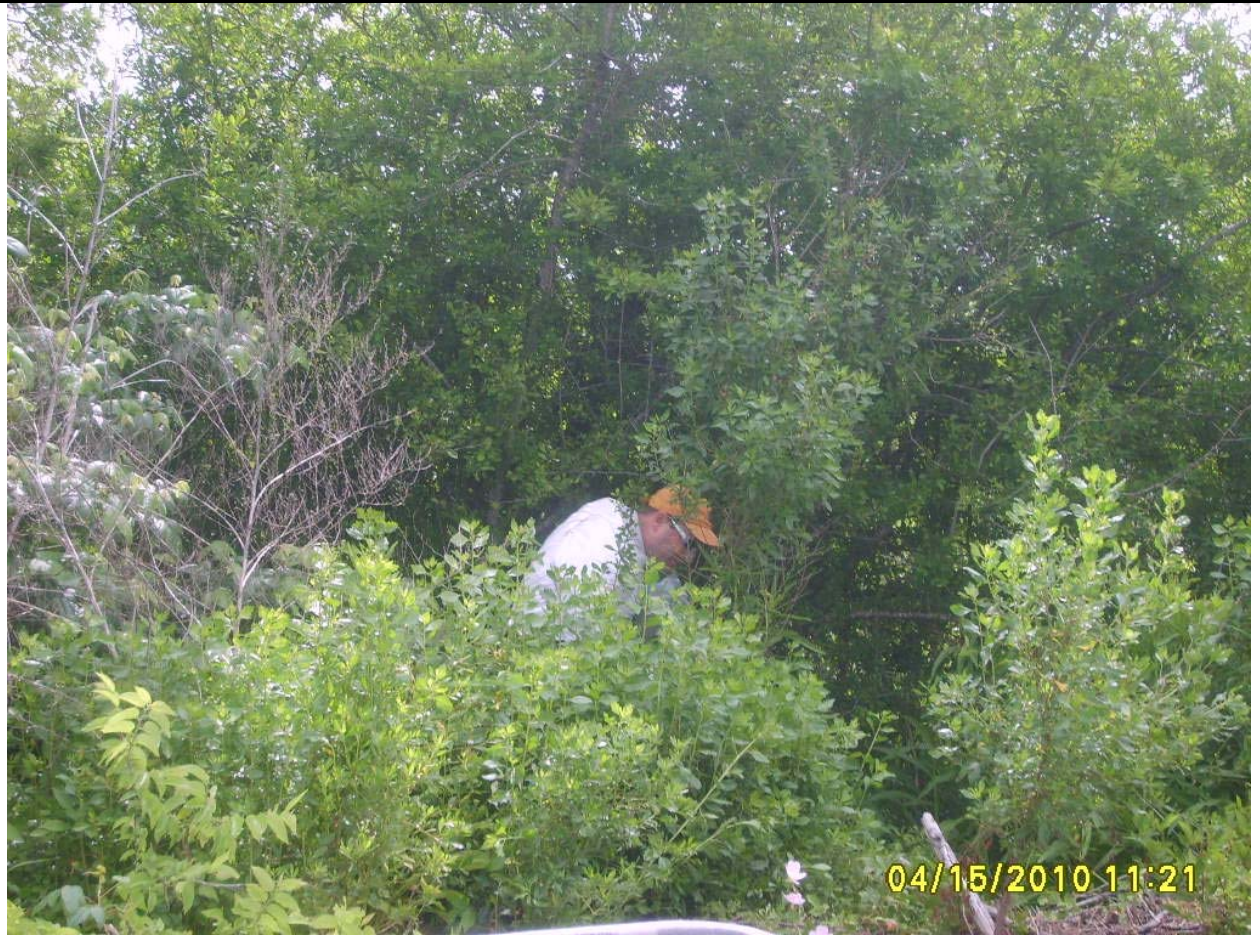
PRP oversight of the actual surface soil sampling locations and methods performed for collection were not observed by Dynamac personnel. This was due to the surface soil sample locations, SJA1 and SJA2, being located within wetlands that were accessible by only mooring the boat at the western edge of the San Jacinto Waste Pits site, walking through densely vegetated land, donning a pair of waders and wading into the exact location to collect the sample.

Logbook Photo #	102-0805
US EPA ID / Task Order Number	TXN000606611 / TO-0002-10-03-02
Site	San Jacinto River Waste Pits
Location Address	29.7944 N, 95.0625 W
City, State, ZIP code	Baytown, Texas
County	Harris
Direction/Orientation	East
Date	April 15, 2010
Time	1113 hrs
Photographer	Karen Berecz (START)
Witness	Jason Kase (PRP Contractor – Anchor QEA)
Description:	
Departing boat to collect samples at SJA1 and SJA2.

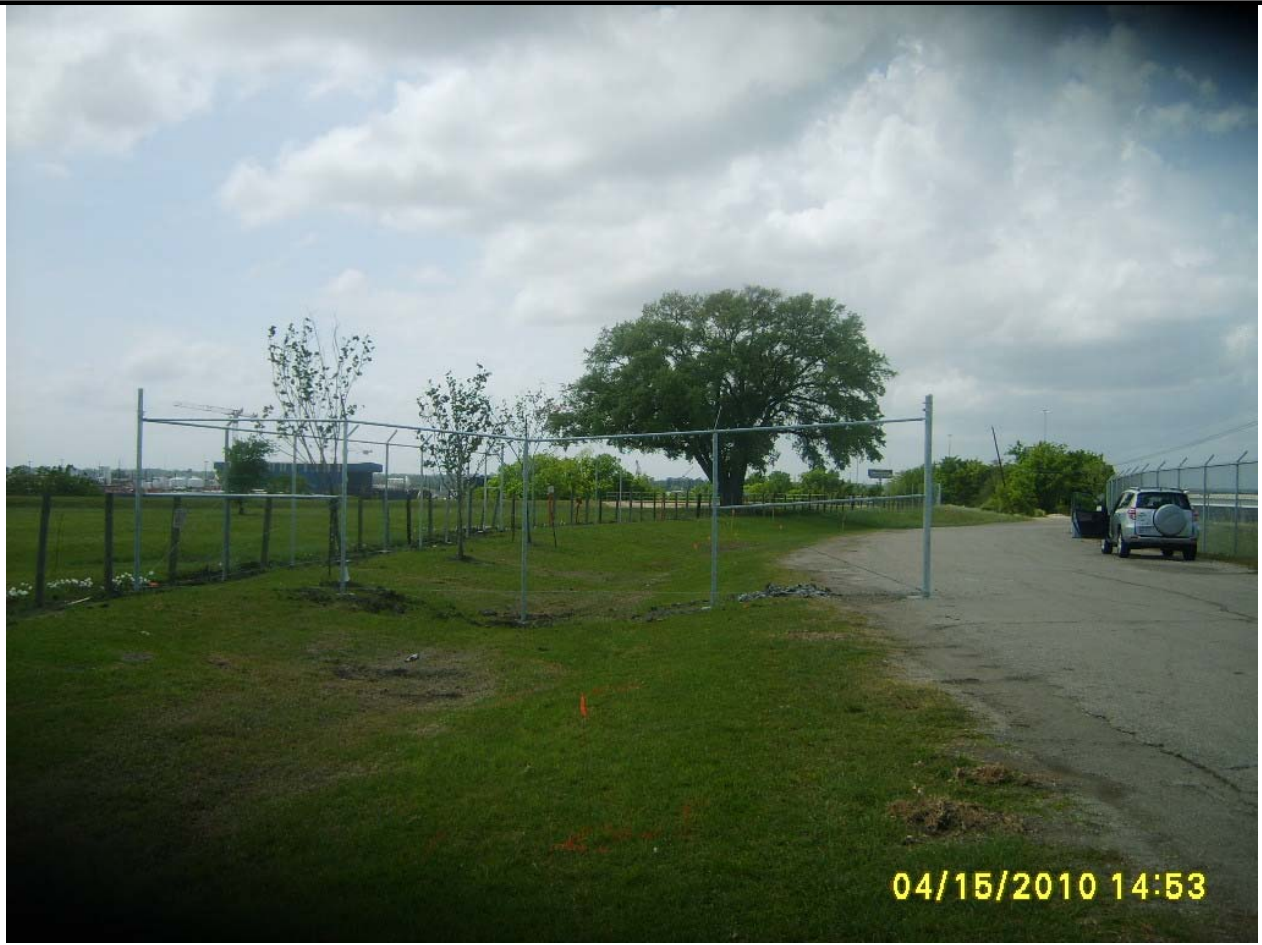
Logbook Photo #	102-0816
US EPA ID / Task Order Number	TXN000606611 / TO-0002-10-03-02
Site	San Jacinto River Waste Pits
Location Address	29.7944 N, 95.0625 W
City, State, ZIP code	Baytown, Texas
County	Harris
Direction/Orientation	West
Date	April 15, 2010
Time	1453 hrs
Photographer	Karen Berecz (START)
Witness	Jason Kase (PRP Contractor – Anchor QEA)
Description:	Entry to area off Crosby-Lynchburg street.

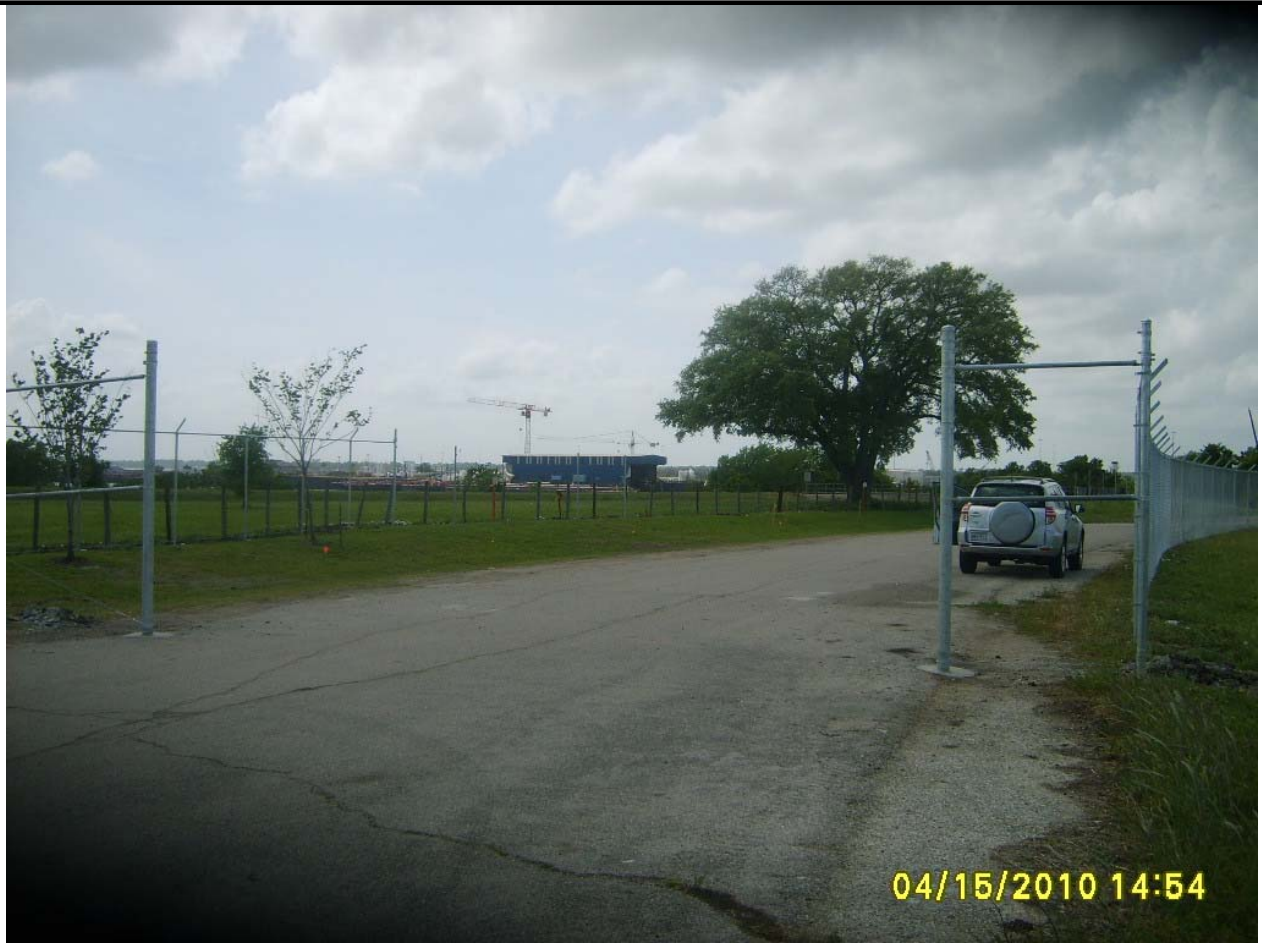
Logbook Photo #	102-0817
US EPA ID / Task Order Number	TXN000606611 / TO-0002-10-03-02
Site	San Jacinto River Waste Pits
Location Address	29.7944 N, 95.0625 W
City, State, ZIP code	Baytown, Texas
County	Harris
Direction/Orientation	West
Date	April 15, 2010
Time	1453 hrs
Photographer	Karen Berecz (START)
Witness	Jason Kase (PRP Contractor – Anchor QEA)
Description:	
Entry to area off Crosby-Lynchburg street.

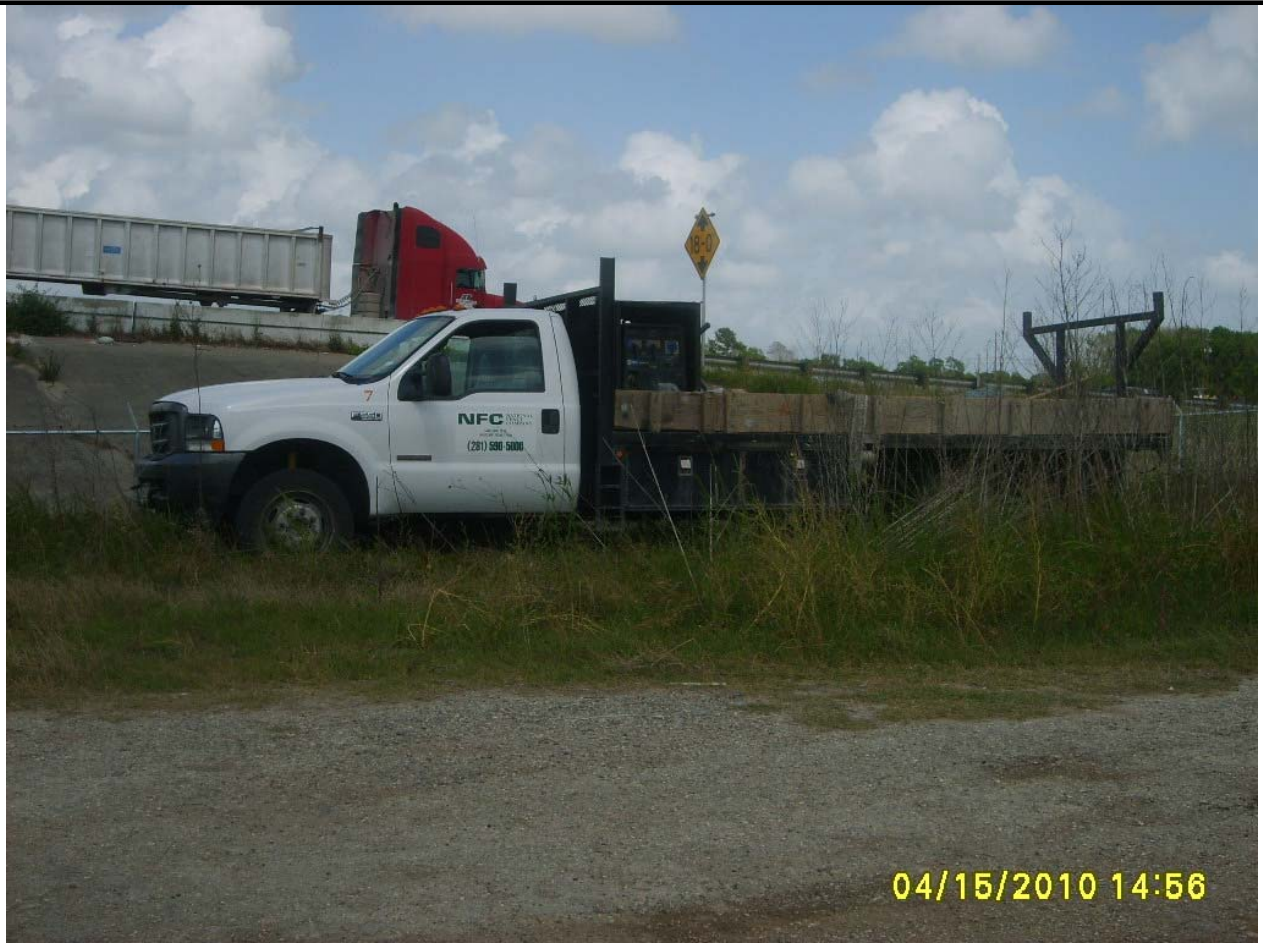
Logbook Photo #	102-0818
US EPA ID / Task Order Number	TXN000606611 / TO-0002-10-03-02
Site	San Jacinto River Waste Pits
Location Address	29.7944 N, 95.0625 W
City, State, ZIP code	Baytown, Texas
County	Harris
Direction/Orientation	West
Date	April 15, 2010
Time	1454 hrs
Photographer	Karen Berecz (START)
Witness	Jason Kase (PRP Contractor – Anchor QEA)
Description:	
Entry to area off Crosby-Lynchburg street.

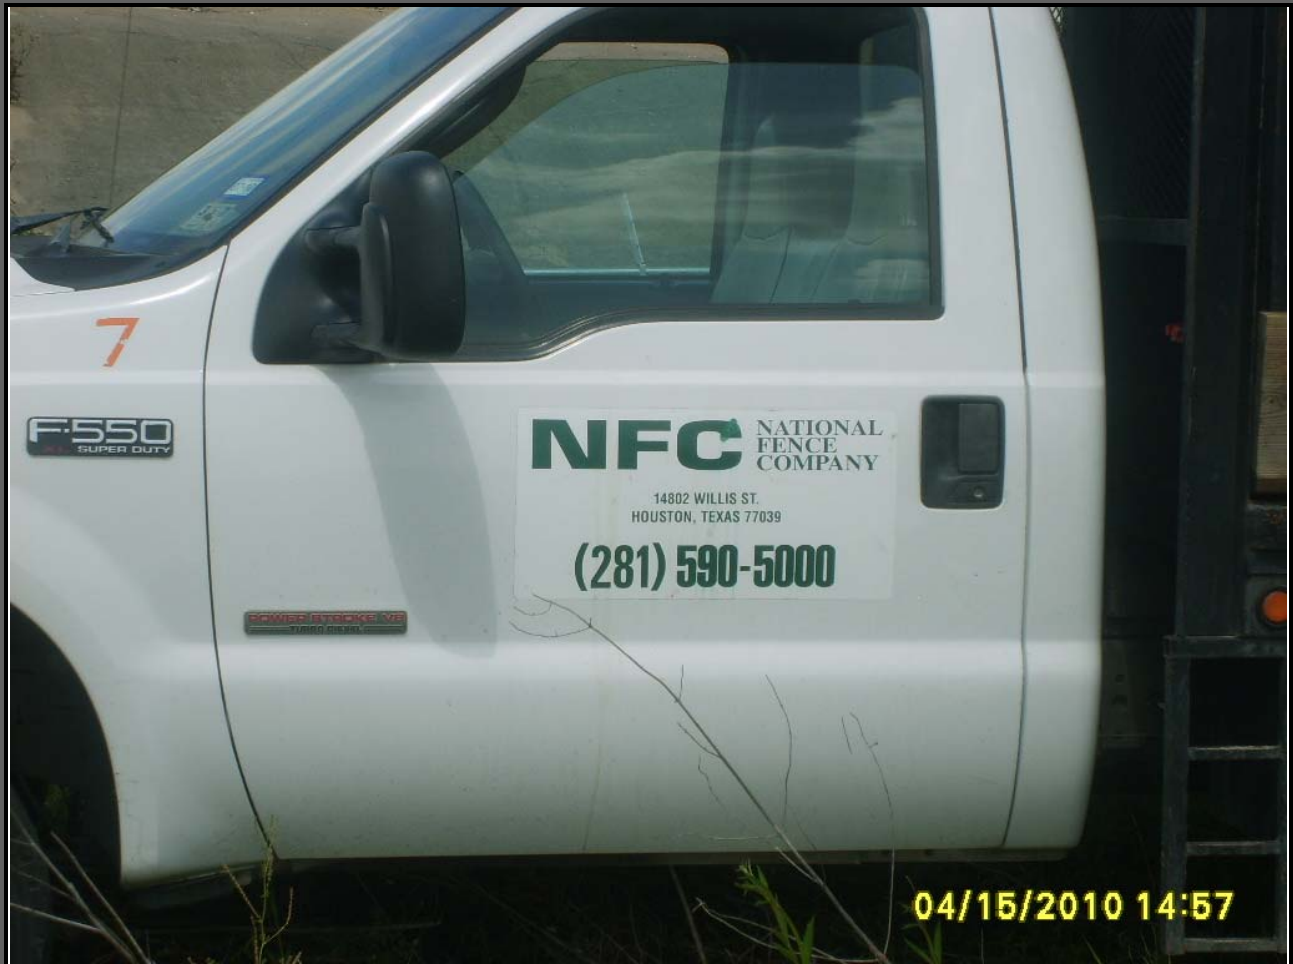
Logbook Photo #	102-0819
US EPA ID / Task Order Number	TXN000606611 / TO-0002-10-03-02
Site	San Jacinto River Waste Pits
Location Address	29.7944 N, 95.0625 W
City, State, ZIP code	Baytown, Texas
County	Harris
Direction/Orientation	North
Date	April 15, 2010
Time	1456 hrs
Photographer	Karen Berecz (START)
Witness	Jason Kase (PRP Contractor – Anchor QEA)
Description:	National Fencing Company (NFC) vehicle on-site. Crew currently installing fence.

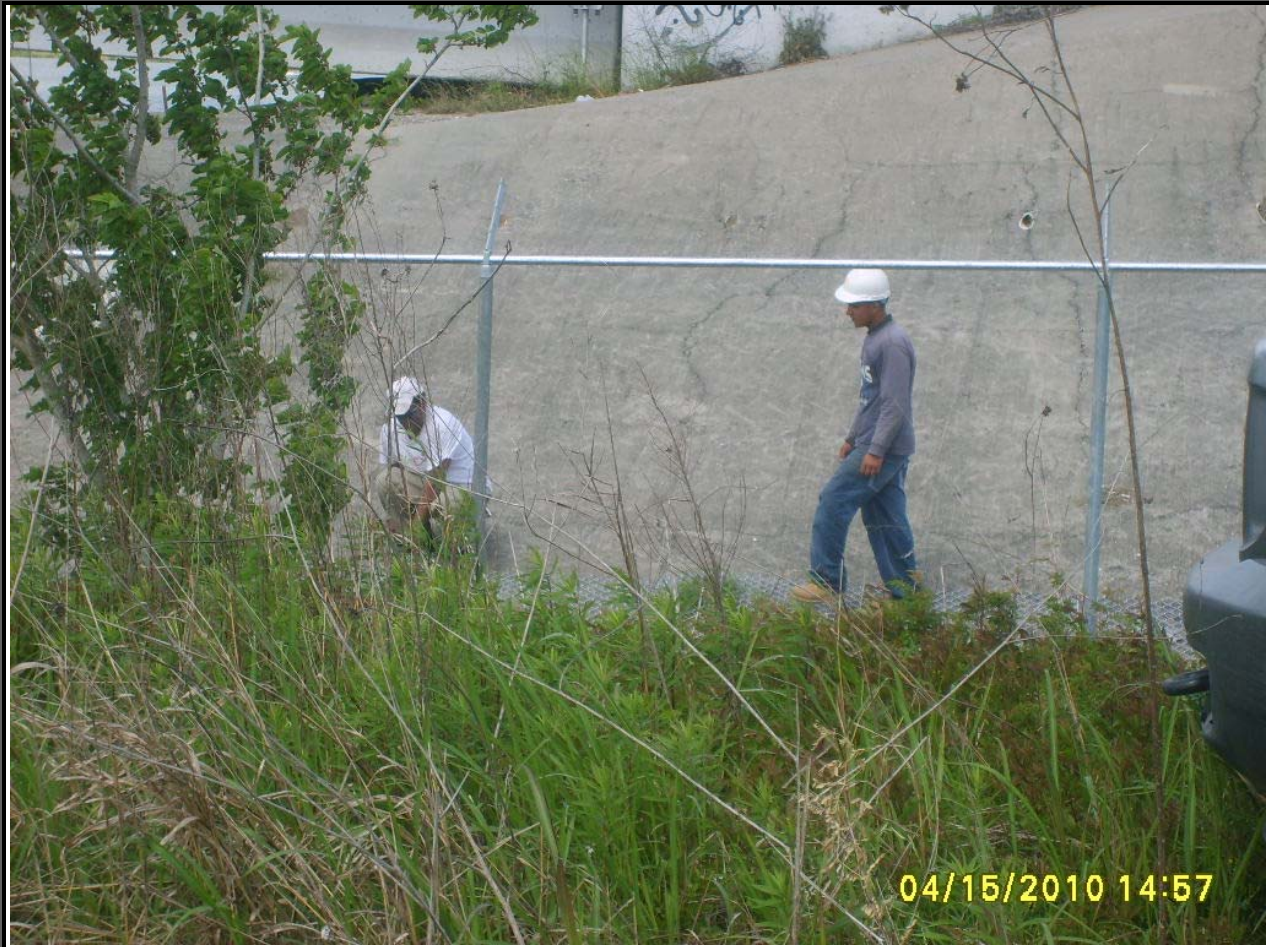
Logbook Photo #	102-0820
US EPA ID / Task Order Number	TXN000606611 / TO-0002-10-03-02
Site	San Jacinto River Waste Pits
Location Address	29.7944 N, 95.0625 W
City, State, ZIP code	Baytown, Texas
County	Harris
Direction/Orientation	North
Date	April 15, 2010
Time	1457 hrs
Photographer	Karen Berecz (START)
Witness	Jason Kase (PRP Contractor – Anchor QEA)
Description:	
National Fencing Company (NFC) vehicle on-site. Crew currently installing fence.

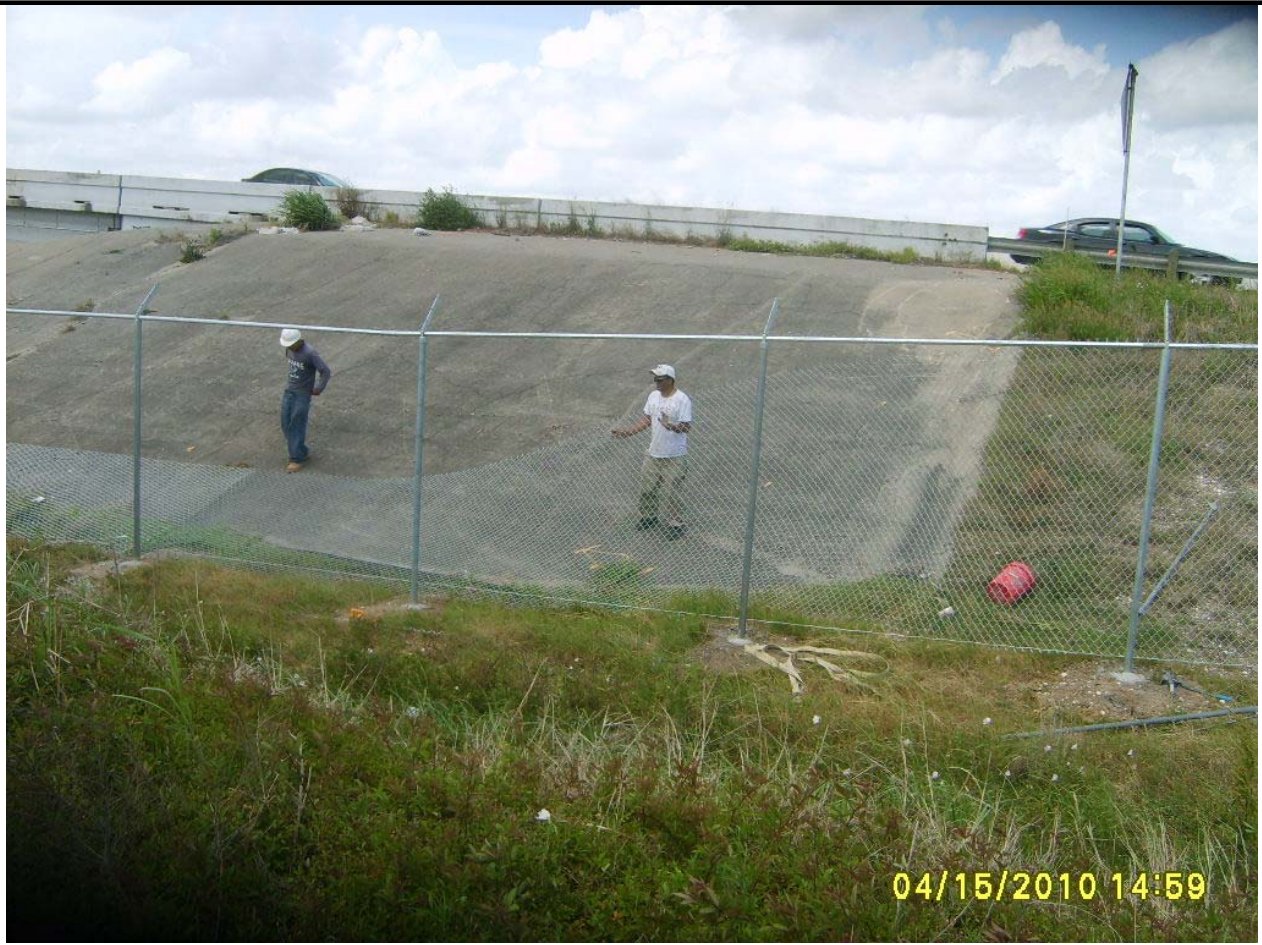
PHOTO 102-0821 AND 102-0822 LOOKING NORTH. NFC CREW INSTALLING FENCING. PHOTO 102-0823. LOOKING ~~WEST~~ EAST AT ENTRY TO AREA. NO GATE INSTALLED OR SIGNAGE.

Logbook Photo #	102-0821
US EPA ID / Task Order Number	TXN000606611 / TO-0002-10-03-02
Site	San Jacinto River Waste Pits
Location Address	29.7944 N, 95.0625 W
City, State, ZIP code	Baytown, Texas
County	Harris
Direction/Orientation	North
Date	April 14, 2010
Time	1457 hrs
Photographer	Karen Berecz (START)
Witness	Jason Kase (PRP Contractor – Anchor QEA)
Description:	National Fencing Company (NFC) crew installing fencing.
